## Basic Study on Detection of Deteriorated RC Structures Using Infrared Thermography Camera

Fumio Yamazaki<sup>1,a,\*</sup>, Hideomi Ueda<sup>2</sup>, and Wen Liu<sup>1,b</sup>

<sup>1</sup> Department of Urban Environment Systems, Chiba University, Chiba 263-8522, Japan

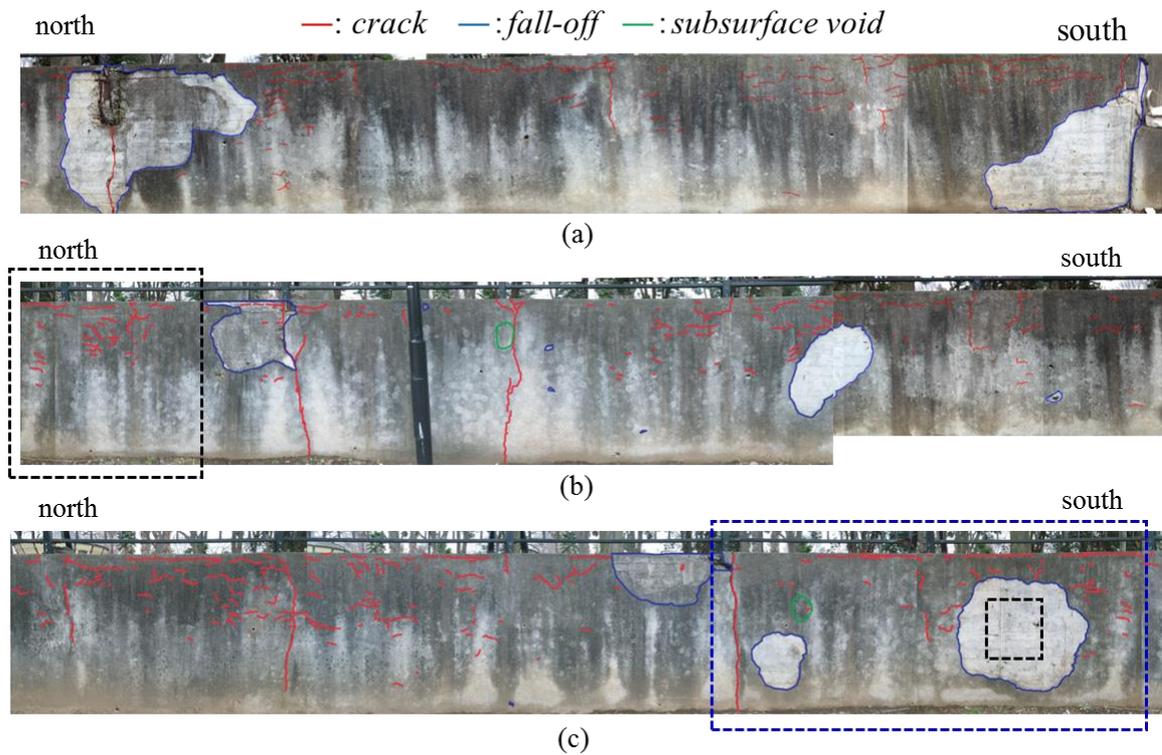
Observation of the RC retaining wall was carried out from 11:00 to 19:30 on July 8, 2014. The weather was sunny with the maximum temperature  $32^\circ\text{C}$  and minimum temperature  $21^\circ\text{C}$ . The sun light illuminated the wall from about 12:30 until about 18:00. These conditions were suitable for infrared thermography. The surface temperature of the RC wall was observed every 30 minutes by the infrared thermography camera. Before starting the tests, the target retaining wall was inspected visually as shown in Fig. 4. It is clearly observed that the cover mortar of the retaining wall had been deteriorated and fall-off holes of mortar were observed at several locations. Deep cracks were also developed to the surface and body of the wall. The existence of voids underneath the cover mortar was also suspected at some locations but it was not so obvious by visual inspection.

Fig. 4. Photograph of the west surface of the RC retaining wall. The order of (a), (b), and (c) from the south to the north. Deterioration stage was visually inspected and the results were plotted by red line (crack), blue line (flaking hole), and green line (suspected subsurface void). Blue dotted line shows the primary survey area and black dotted line is the Schmidt hammer test area.

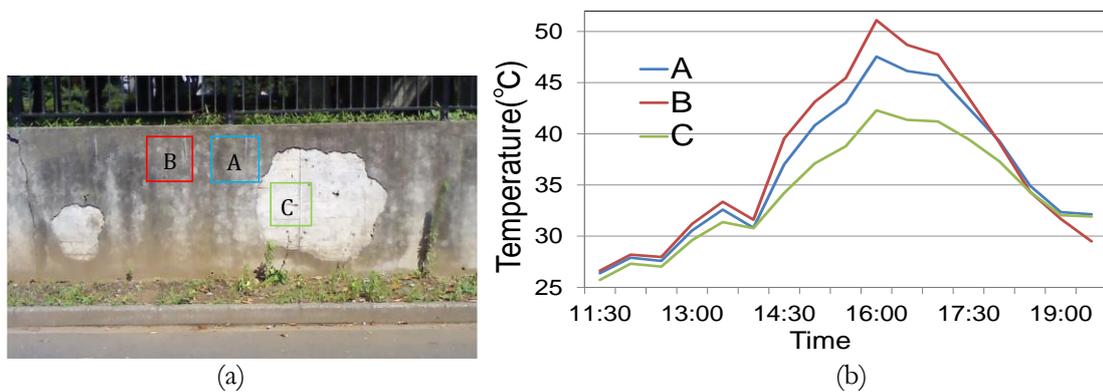
Figure 5(a) shows the photograph of the concrete retaining wall including three areas (the blue dotted square in Fig. 4) that were chosen for calculating the mean values of temperature and the temperature change in time (Fig. 5(b)). From this figure, the amount of temperature rise was large in the order of the areas B, A and C. In the area B, in addition to the highest temperature rise, the surface temperature dropped sharply after the sunset. If the wall has internal voids, the heat transfer is blocked by the voids and the heat is likely to accumulate in the surface layer. Accordingly, the temperature increases sharply in the heating time. In the cooling time, the heat in the surface layer is lost in a short time and thus the temperature decreases sharply. Based on this reason and the temperature change in each area, there was high possibility that the areas B and A had internal voids.

Fig. 5. (a) Location of three typical parts of the measurement area on the retaining wall and (b) the change of temperature in time at these parts on July 8, 2014.

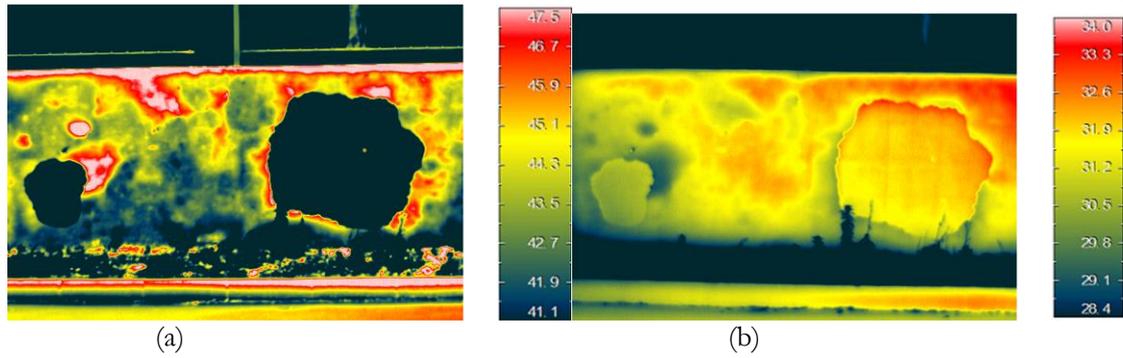
Figure 6 shows the distribution of surface temperature at two time instants, 15:30 and 19:30. The surface temperature shows clear difference at the three locations. At the area C, the solid concrete body was exposed and hence a long time was needed until its surface temperature went up. Thus in the stage of heating (15:30), the solid parts, like the area C, have much lower temperature than other parts. On the contrary, the surface temperature went up much faster at suspected deteriorated parts, such as B and A, in the heating stage. But when the heating stopped and the air temperature went down (19:30), the reverse phenomenon was observed. Heat was lost from the deteriorated parts faster than that of the solid part and the surface temperature of the solid part was kept higher than that of the deteriorated parts.

Fig. 6. (a) The surface temperature at 15:30 and (b) 19:30 on July 8, 2014, observed by the infrared thermography camera.

The temperature distributions suggest us the location of voids underneath the surface mortar. The position and extent of deterioration could be clearly detected using the thermal infrared images. Hence, thermography is considered to be useful in investigating deterioration of large concrete structures at once in a short time. Since the temperature change is different depending on the deterioration state, thermal imagery is effective for assessing the progress of deterioration. But it should be noted that the heating condition affects the change of surface temperature and its spatial distribution.

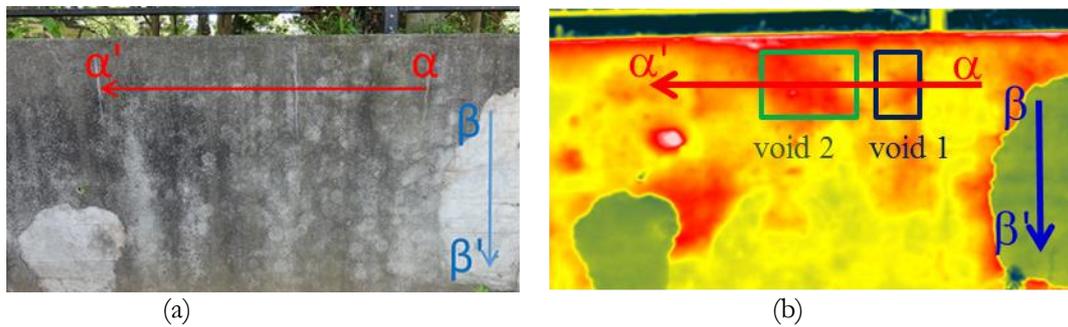
Fig. 7. (a) Measurement area of rotary hammering test (lines  $\alpha$ - $\alpha'$  and  $\beta$ - $\beta'$ ) and (b) thermal images at 15:30, July 8, 2014.

The deterioration condition of the target area (Fig. 5(a)) was examined in more detail along two lines shown in Fig 7(a). From the thermal images, the line  $\alpha$ - $\alpha'$  was selected in the area of suspected deterioration and the line  $\beta$ - $\beta'$  in the area of peeled-off but no internal deterioration. Figure 8 shows the distribution of surface temperature at 15:30 and 19:30 on July 9, 2014 along the two lines. From the figure, it is clearly seen that the suspected deteriorated part with void shows a higher temperature that that of the solid part in the

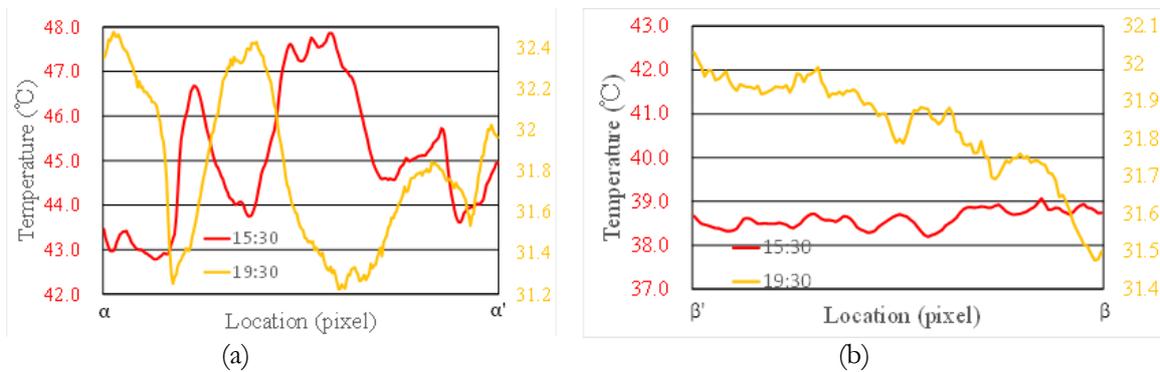
Fig. 8. Distribution of surface temperature at 15:30 (red line) and 19:30 (orange line) on July 8, 2014 along (a) line  $\alpha$ - $\alpha'$  and (b) line  $\beta$ - $\beta'$ .

heating condition. It is particularly interesting that the trend of temperature along the deteriorated part in the heating time and cooling time was just the opposite.

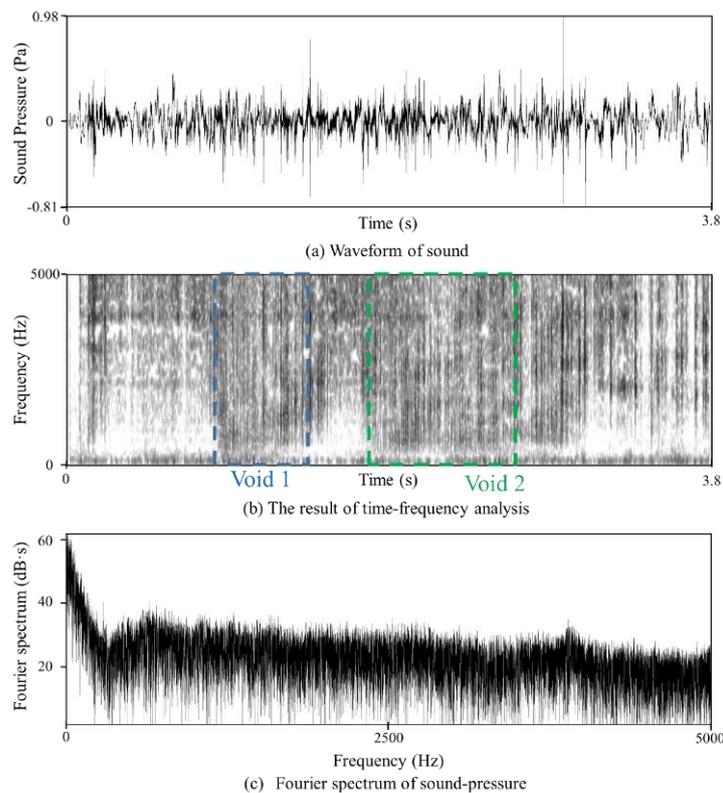
The deterioration state of the concrete retaining wall was also investigated with the rotary hammer in the area that is shown in Fig. 7. The recorded sound time-histories, the results of time-frequency analysis [25], and the Fourier spectra are plotted in Figs. 9 and 10, respectively for the lines  $\alpha$ - $\alpha'$  and  $\beta$ - $\beta'$ . In the time-frequency plots, the dark color indicates large sound-pressure parts. From the sound-pressure Fourier spectra, the line  $\alpha$ - $\alpha'$  (Fig. 9(c)) has both low-frequency and high-frequency contents but the line  $\beta$ - $\beta'$  has low-frequency contents only (Fig. 10(c)). In addition, the areas that were suspected to be deteriorated by time-frequency analysis (Fig. 9(b)) match the estimated deterioration areas by the thermal image (Fig. 7(b)), in which the deterioration areas exhibited significantly higher temperature. This observation from the rotary hammering test provides a further validation of the usefulness of infrared thermography.

Fig. 9. (a) Recorded sound time-history, (b) its running spectrum, and (c) Fourier spectrum by rotary hammer along the line  $\alpha$ - $\alpha'$  on the retaining wall.

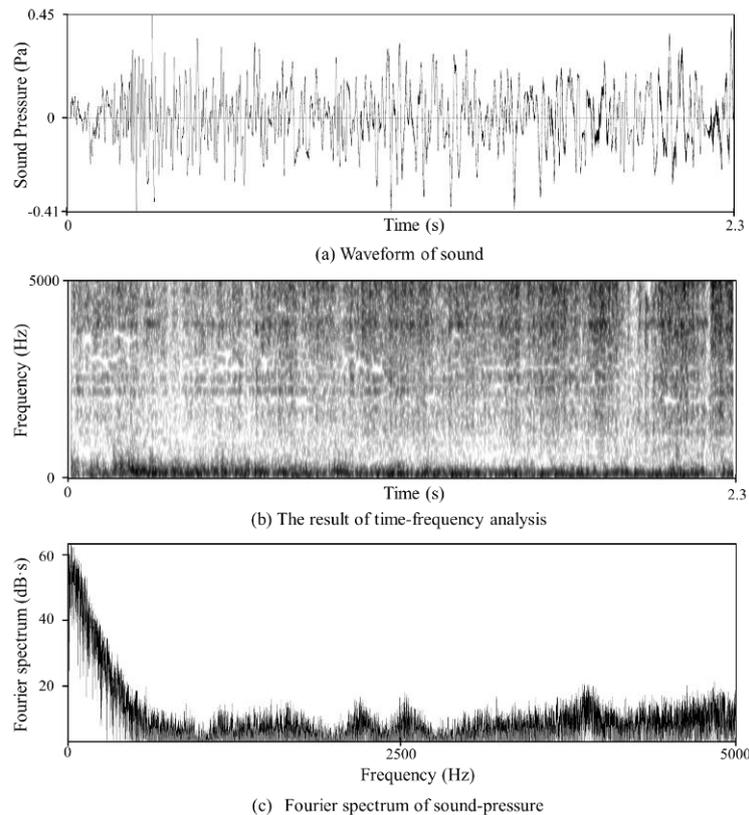
Fig. 10. (a) Recorded sound time-history, (b) its running spectrum, and (c) Fourier spectrum by rotary hammer along the line $\beta$ - $\beta'$  on the retaining wall.

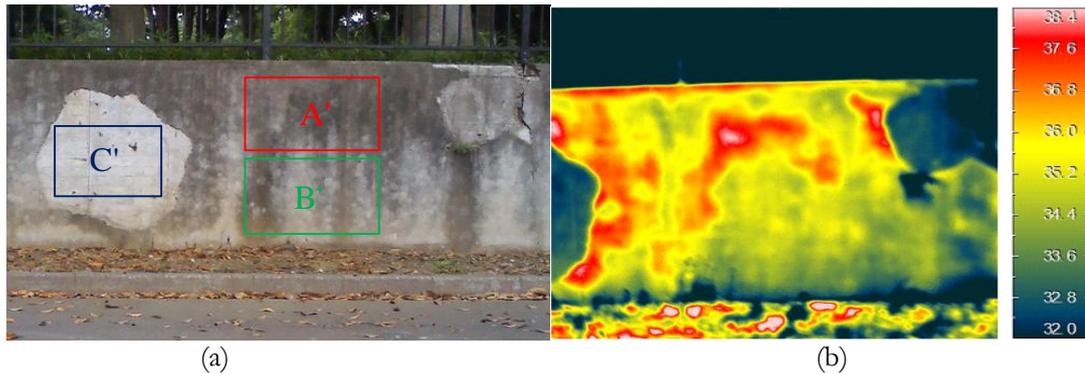
Measurement of the concrete retaining wall by the Schmidt rebound hammer was carried out on June 27, 2013. Three areas measured by Schmidt hammer are illustrated in Fig. 11 and Fig. 4 (dotted black squares). From the thermal image, the area A' was considered to have internal voids, the area B' to be sound and the area C' was already peeled-off and the sound concrete was exposed. In the area A', the rebound value  $R$  was 24.46 and therefore the compressive strength  $F_C$  was calculated by Eq. (1) as 7.87 N/mm<sup>2</sup>. In the area B', the rebound value  $R$  was 28.24 with  $F_C$  10.76 N/mm<sup>2</sup>. The compressive strength of the area B' is about 3 N/mm<sup>2</sup> larger than that of the area A'. In the area A', it was expected that the internal deterioration separated the surface mortar from the wall concrete. For this reason, it seems that the rebound value measured by Schmidt hammer became small. The internal state of structures affects the rebound value and thus Schmidt hammer could detect internal deterioration.

The rebound value of area C' was 37.95 with  $F_C=18.19$  N/mm<sup>2</sup>, which was much larger than those of the areas A' and B'. Therefore, it was found that the both areas A' and B' have internal deterioration and, in particular, it is remarkable in the area A'. However, the area B' was estimated sound from the thermal image. Thus, if the deterioration spreads in a wide area, the selection of comparison objects is very important to avoid wrong diagnosis.

Fig. 11. (a) Measurement areas by Schmidt hammer on July 27, 2013; and (b) the corresponding thermal image.

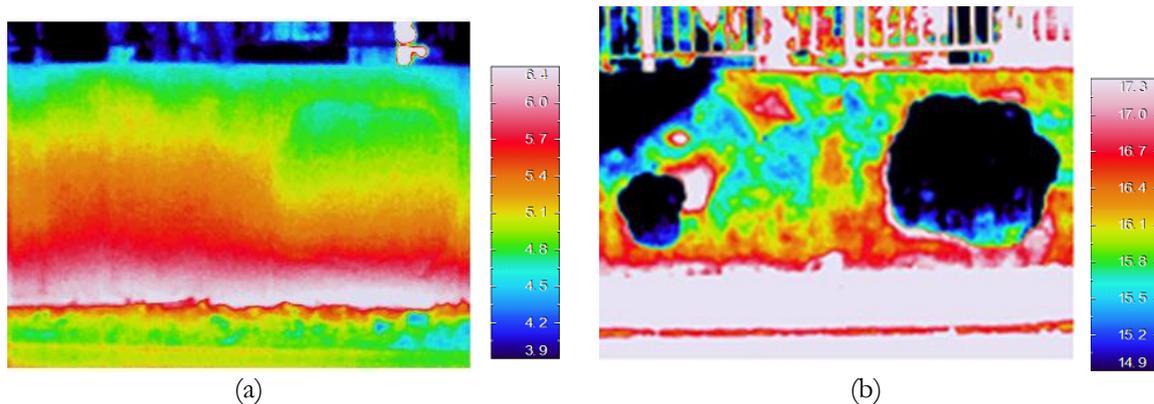
The temperature distribution of a concrete surface is considered to be affected by wetness condition as well as heating condition. Figure 12 (a) shows the temperature distribution of the retaining wall in the rain at 14:00 on December 16, 2014. No natural heating (the sun) was given on the day and because the wall was wet by rain, the temperature distribution was rather uniform. The surface temperature of the upper part of the wall was lower probably due to the loss of vaporization heat. It is considered to be difficult to detect deteriorated parts from infrared thermography on rainy days.

Measurement was also conducted on the time after rain stopped and the sun light illuminated the wall, at 13:00 on November 27, 2014 (Fig. 12(b)). The deteriorated parts were clearly identified by this image because the deteriorated parts dried up faster than other parts due to trapped heat. But the wetness condition is considered to be another factor to determine the surface temperature. Thus the condition of measuring objects should be examined carefully before conducting infrared thermography.

Fig. 12. (a) Thermal image measured in the rain at 14:00 on December 16, 2014; and (b) one just after rain stopped at 13:00 on November 27, 2014.
