## Effect of Water Level Fluctuation on Riverbank Stability at the Estuary Area of Muaro Kualo Segment, Muara Bangkahulu River in Bengkulu, Indonesia

**Abstract.** The paper presents an investigation of riverbank stability at the estuary area of Muaro Kualo Segment, Muara Bangkahulu River in Bengkulu, Indonesia. This area had experienced slope failures along the riverbank during the Bengkulu flood in 2019. This study is initiated by conducting a geotechnical survey to observe site condition. During the survey, slope geometry measurement and soil sampling are performed. The laboratory tests are performed to collect physical and engineering soils properties. The rainfall intensity during period of 2011-2020 is also collected to observe normal and critical river water level. The finite element method is employed to analyse the slope stability analysis under the normal and critical river water level conditions. The results showed that the slope failure is generally initiated at the slope toe. Because of the river water level, factor of safety of slope along the estuary is less than the minimum criteria for the stable slope. It indicates that slope failure is very possible to occur. Im

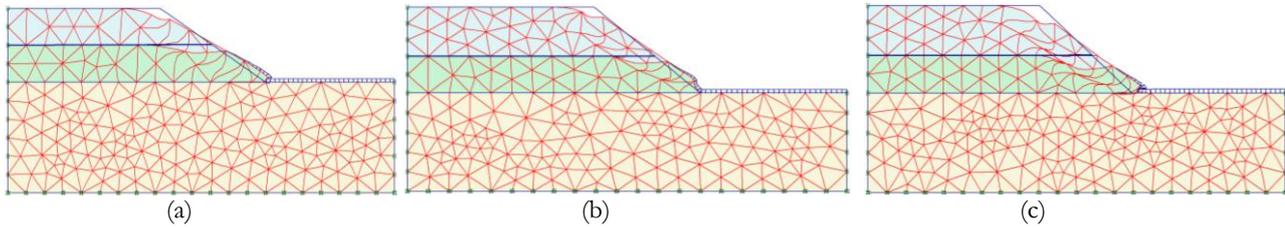
The results of finite element simulation for slope stability analysis are presented in Figs. (6) to (9). In this study, some slopes that are assumed as the representative slopes. They are MK-2, MK-6, and MK-9. MK-2, MK-6, and MK-9 represent the front-side segment slope, middle-side segment slope, and back-side segment slope, respectively. Figures 6 and 7 showed the mesh deformation under both normal and critical conditions. It can be seen that the deformation is generally started at slope toe. It indicates that the slope tends to undergo sliding starting at slope toe. Generally, both conditions showed that failure surface could occur along the slope body. To observe the sliding planes on the investigated slopes, the sliding surfaces on three representative slopes are presented in Figures 8 and 9. In general, it can be observed that there is no significant difference between normal condition and critical condition. The sliding surface is generally occurred at the slope body. It indicates that both conditions could influence slope stability in the study area.

Fig. 6. Mesh deformation slope under normal condition at (a) MK-2 (b) MK-6 and (c) MK-9.

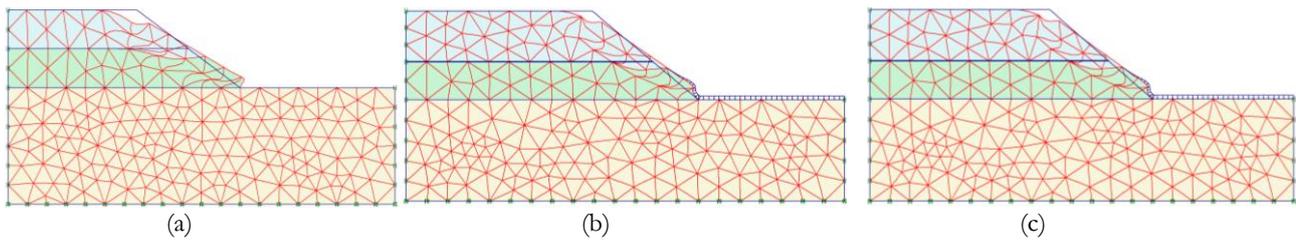
Fig. 7. Mesh deformation slope under critical condition at (a) MK-2 (b) MK-6 and (c) MK-9

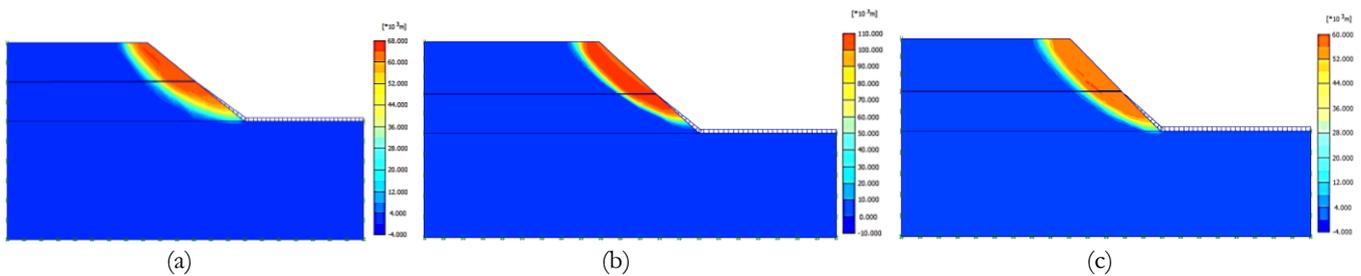
Table 6 presents the summary of total displacement on each slope, under both normal and critical conditions. It can be seen that under normal condition, the displacement is observed to vary from 0.81 to 2.26 m. For critical condition, it can be observed that under the critical condition, the total displacement is observed to vary from 1.22 to 1.88 m. This is due to the fact that slope has been getting saturated before the increase of river water level. However, in terms of total displacement, the critical condition tends to yield larger values than normal condition. Generally, the percentage of total displacement difference under both normal and critical conditions is observed to vary from 7.41 to 88.4%. The larger displacement could be resulted by the overflowing of riverbank slope due to the increase of river water level [43]. In the link to Figs. 8 and 9, it can be observed that the maximum displacement is generally occurred at the slope body; whereas Figs. 6 and 7 show the extreme displacement occurred at slope toe. It indicates that there is the accumulation of shear strength reduction due the increase of pore water pressure resulted from the increase of river water level. Several studies conducted by Gill *et al.* [44], Sobhanmanesh *et al.* [45], Bushira *et al.* [46] also show the similar trend of displacement. Singh *et al.* [47] mentioned that the extreme displacement at slope toe indicates the slope tends to be more vulnerable to fail down. Therefore, it can be roughly predicted that the slope failure in the riverbank slope is initiate by the shear strength reduction at slope toe.

Fig. 8. Sliding surface slope under normal condition at (a) MK-2 (b) MK-6 and (c) MK-9.

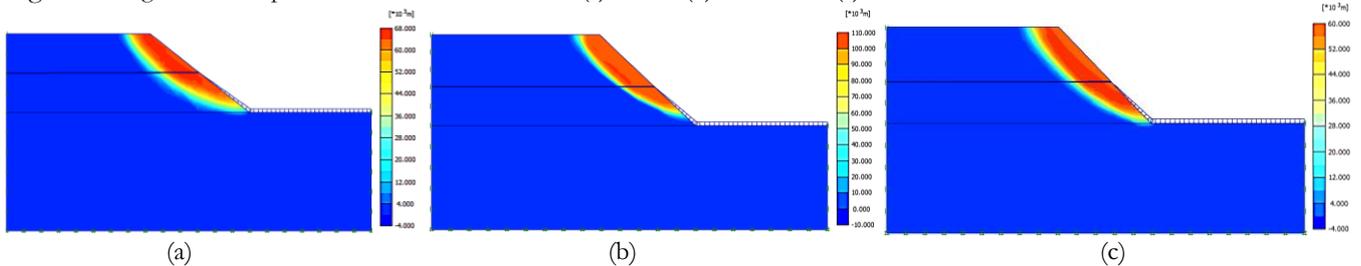
Fig. 9. Sliding surface slope under critical condition at (a) MK-2 (b) MK-6 and (c) MK-9.

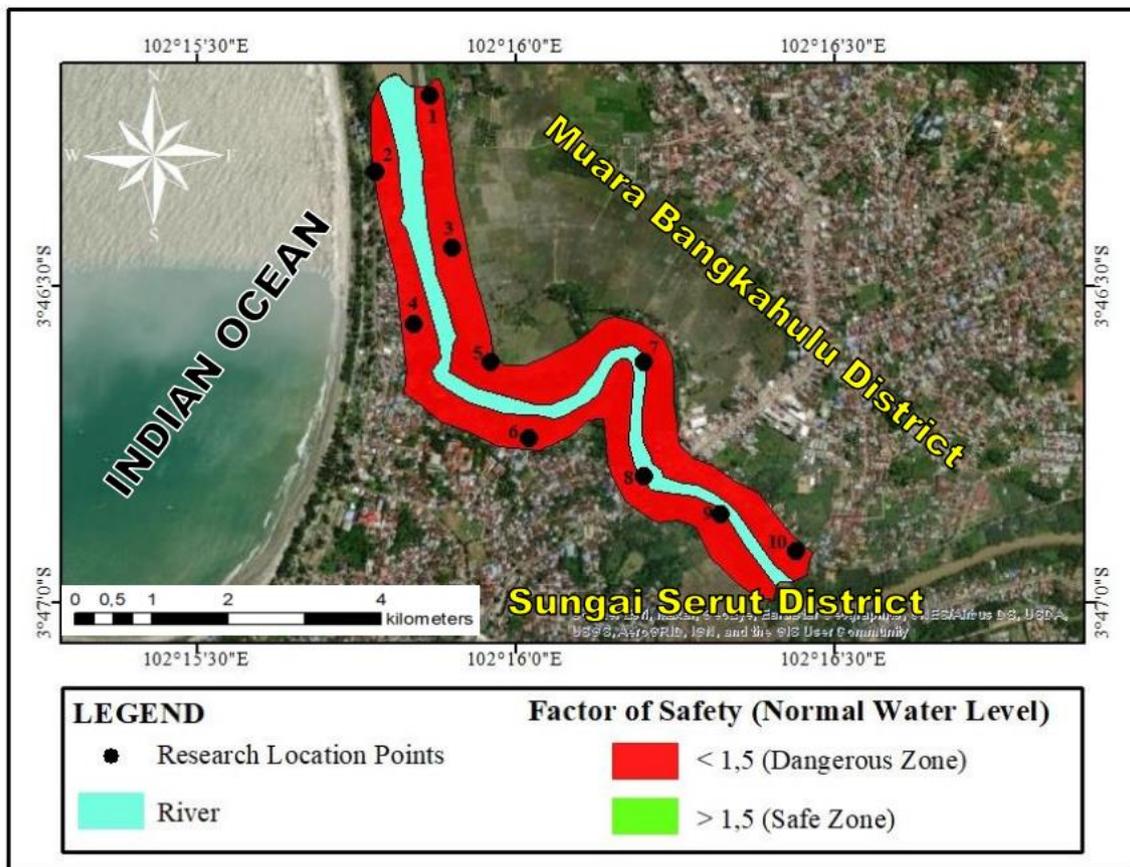
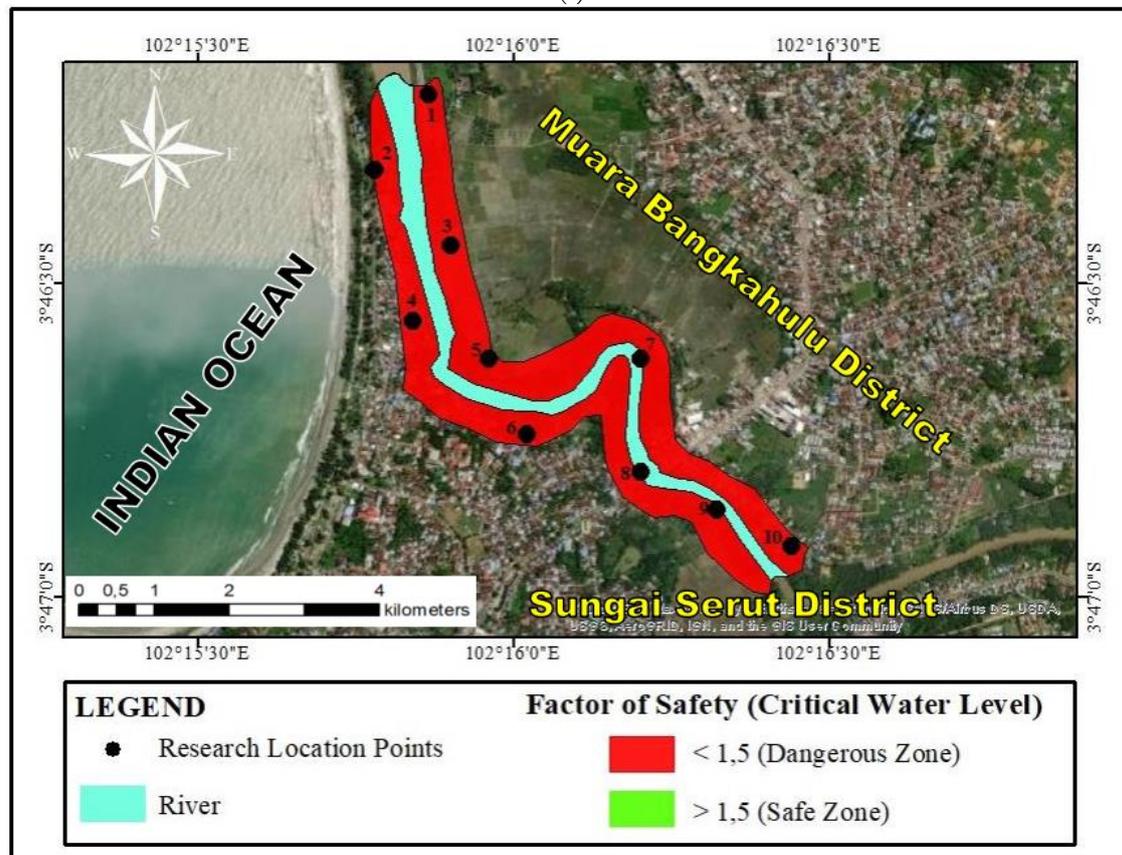
Figure 10 presents the zone distribution of slope vulnerability based on factor of safety, for Muaro Kuala Segment. As presented in Section 3.2, FS at each investigated site presents value less than 1.5. This

threshold is used as the parameter to define the stability of slope. Therefore, under both normal and critical conditions, it can be observed that the investigated locations can be categorised as the vulnerable area to undergo slope failure during the effect of river water level change.

Fig. 10. Zones of slope vulnerability (basic map modified from Google Earth [12]) for Muaro Kualo Segment under (a) normal condition; (b) critical condition.

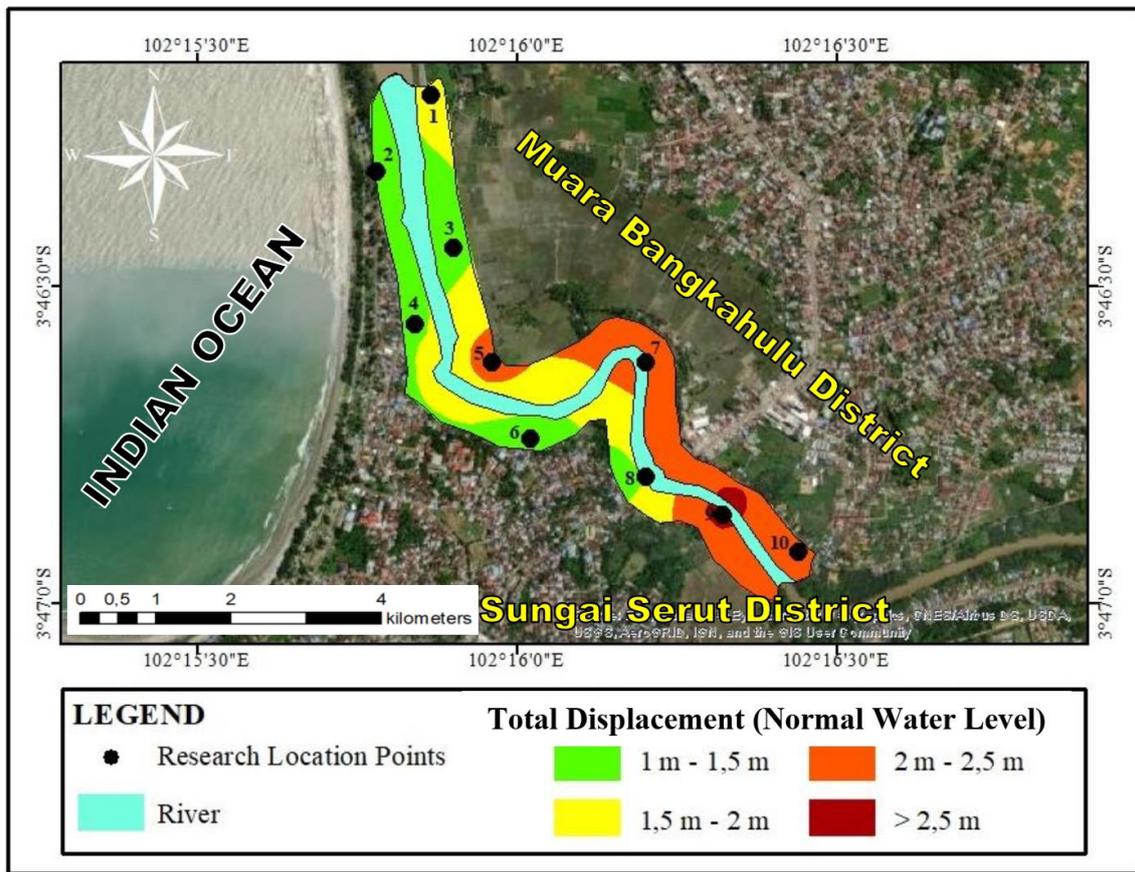
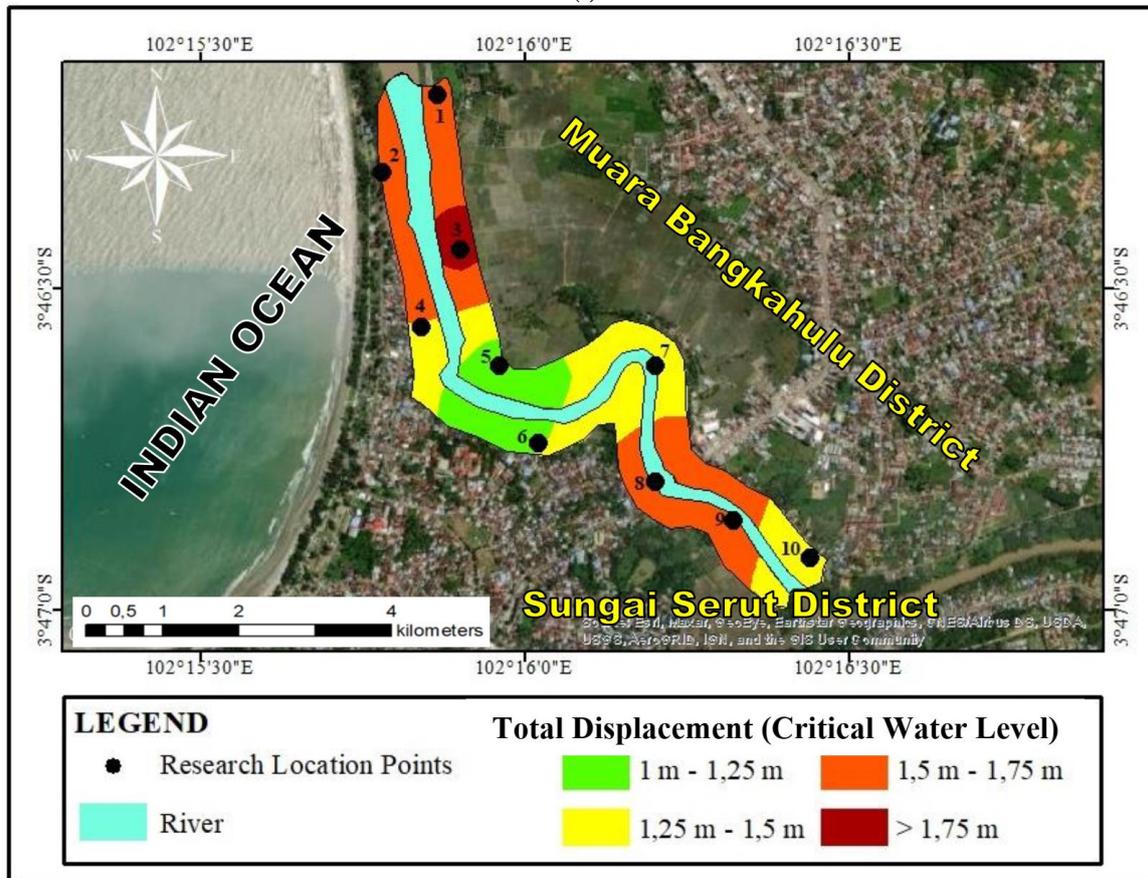
Figure 11 presents the zone of slope displacement for Muaro Kualo under normal and critical conditions. For normal condition (Fig. 11(a)), it can be seen that the area in northern segment part is generally dominated by displacement varying from 1 to 1.5 m. For eastern to southern segment parts, the displacement is generally observed to vary from 2 to 2.5 m. In the middle part of segment, the displacement is generally observed to vary from 1.5 to 2 m. For critical condition (Fig. 11(b)), the displacement on the northern and southern segment parts is about 1.5 to 1.75 m, whereas the displacement on the middle part of segment part is observed to vary from 1.25 to 1.5 m. In general, there is no significant difference on the displacement zonation under both conditions. This is due to the fact that under both conditions, slopes on Muaro Kualo Segment have been potentially failure. The results of this study could recommend slope countermeasure for study area.

Fig. 11. Zones of total displacement (basic map modified from Google Earth [12]) for Muaro Kualo Segment under (a) normal condition; (b) critical condition.

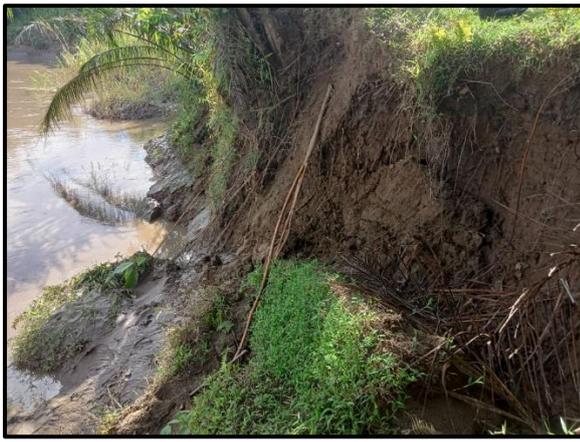
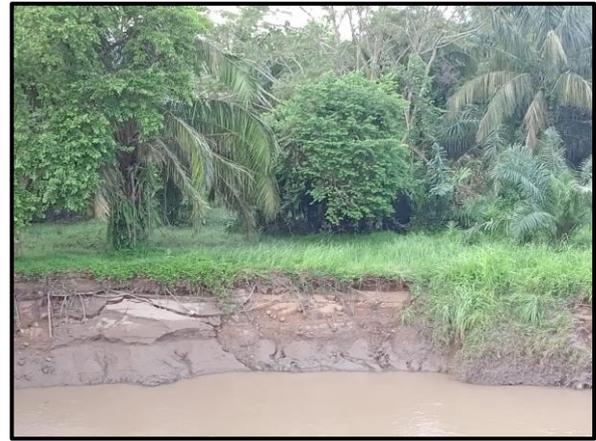
Muaro Kualo is known as the port area that is very important to support socio-economic sector in Bengkulu City. However, the effect of flood during last 10 years has significantly influenced the riverbank slope. Figure 12 presents evidence of slope failure after the Bengkulu flood in April 2019. Figure 12(a) shows a massive slope failure at MK-2 and Fig. 12(b) shows the scouring effect at MK-9 due to the river stream during the flood. Based on the evidence, it can be seen that the slope damage is not only coming from the increase of river water level but also the high-speed of river stream scouring slope body along the segment. A slope countermeasure effort has been currently implemented to the segment. The slope countermeasure method implemented to the riverbank slope of Muaro Kualo Segment is the application of concrete sheet piles, especially at the port area, as presented in Fig. 13. In Fig. 13(a), it can be seen

Fig. 12. Slope damage due the Bengkulu Flood in April 2019 (a) slope failure at MK-3; (b) scouring slope at MK-7.

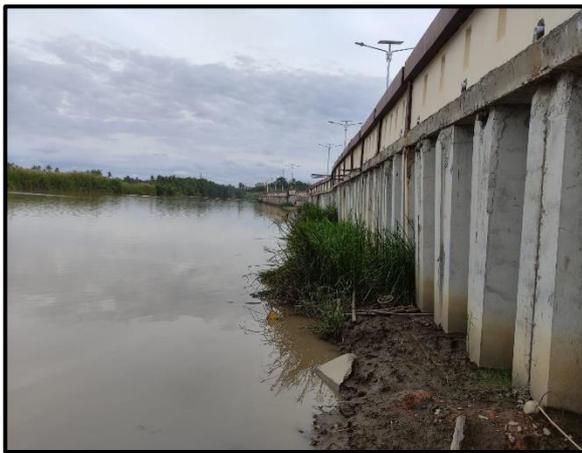
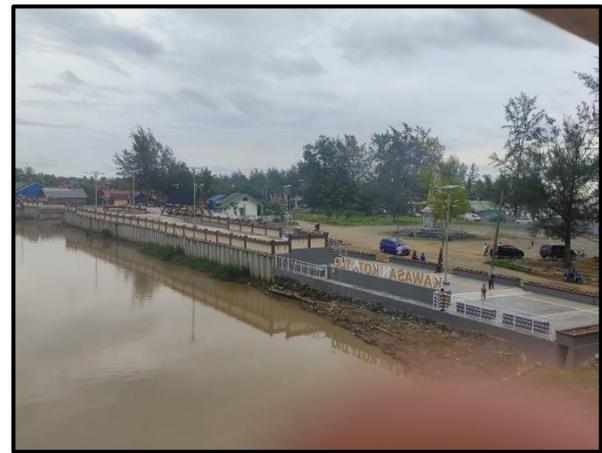
Fig. 13. Slope countermeasure at port area of Muaro Kualo Segment (a) the implementation of sheet pile; (b) top view of port area.

that the concrete sheet piles are installed at the slope toe of estuary riverbank. The construction of sheet pile is inserted to the slope toe and at the gap between the sheet pile and the top of slope is constructed as the new port for Muaro Kualo segment (Fig. 13(b))

4. The slope countermeasure by using concrete sheet pile is selected to solve the problem of slope failure in the study area. In general, the implementation of slope countermeasure method significantly improves slope stability in the study area up to 1.64. The slope countermeasure could significantly reduce the effect of overflowing of river water level, increase the slope stability, and reduce the scouring potential. The slope countermeasure implementation could maintain the function of old port of Bengkulu city to support the socio-economic aspect in Muaro Kualo Segment.

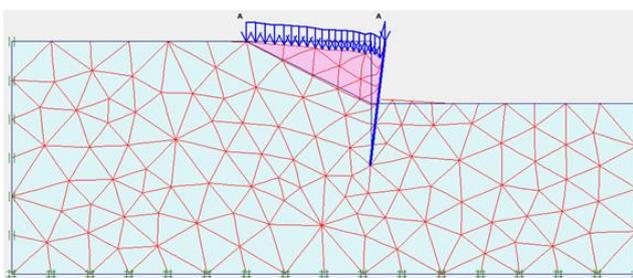
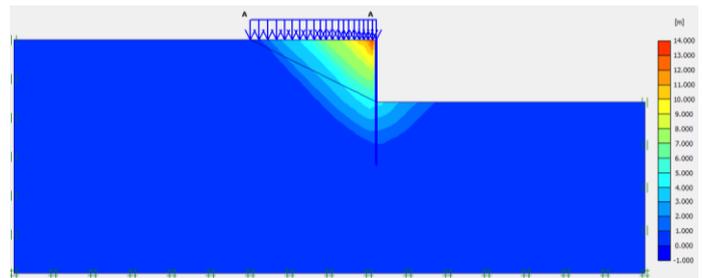
A finite element analysis to the existing slope countermeasure is performed. Figure 14 presents the results of finite element analysis for the implementation of slope countermeasure effort. The slope countermeasure is conducted by installing concrete sheet piles with the buried length of about 4 m and the free length of about 4 m. In this study, axial stiffness (EA), bending stiffness (EI), plate thickness (d) and Poisson's ratio are assumed to be 3,250,000 kN/m<sup>2</sup>, 28,600 kN/m<sup>2</sup>, 0.325 m and 0.15, respectively. The model material is assumed as linear elastic model. For the space between the sheet pile and top of slope, the backfill material is compacted. At the top of sheet piles, a concrete plate is constructed as the pier. In general, the use of sheet pile is destined to avoid overflowing of river water and to avoid infiltration of river water to slope toe. In terms of erosion of soil due to river stream, sheet pile is also addressed to avoid the scouring effect. In analysis, step of construction is performed. the pile is initially installed and loading is applied. In this study, the surcharge load is acted behind sheet pile. Based on Fig. (14), it can be seen that during the critical condition, the failure surface generally occurs at the top of sheet pile (Fig. 14(a)). The maximum displacement is presented in Fig. 14(b). The maximum displacement occurred is located behind the sheet pile, which is the interface zone between load and sheet pile. FS under the condition is about 1.64. In general, FS of the slope countermeasure has been exceeded the minimum required FS. Therefore, the implementation of sheet piles as slope countermeasure effort for study area is relevant and reliable to the condition on the estuary area.

Fig. 14. Finite element results for slope countermeasure effort (a) mesh deformation; (b) sliding surface.
