Residual Strength of Composite Unprotected Steel-Deck Floor Exposed to High Temperature (Fire Flame)

ENGINEERING JOURNAL Volume 22 Issue 1

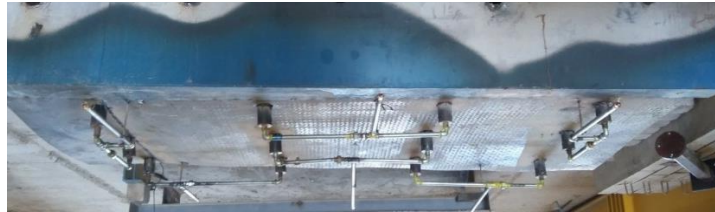
Fig. 3. Twelve nozzles to distribute fire flame underneath the specimen.

- Exposure to high temperature (fire flame): three specimens named as $SB-RC_{300}$, $SB-RC_{500}$ and $SB-RC_{700}$ were exposed to high temperatures of 300, 500 and 700°C , respectively, simultaneously with applied uniformly constant equivalent load. Then they were cooled gradually by leaving them at ambient lab conditions. The temperature was monitored by using digital thermometer readers with thermocouple sensor wires type K fixed at the top concrete surface of the mid span (Fig. 2). The temperature controlled during the burning by the amount of methane gas reach to the nozzles. The furnace was manufactured by using one 3-mm-thick steel plate having a U-shape to restrict heat from the bottom and sides, and the burned composite SB-RC deck floor from the top, as shown in Figs. 3 and 4. Its dimensions were appropriately matched with the specimen's dimensions so as to leave enough space underneath the composite SB-RC deck floor to reach and disperse the fire flame from the sources (nozzles) to the composite SB-RC deck floor. The nozzles were positioned with 12 in the bottom of the furnace, and four in three rows along the bottom of the specimen, to simulate lower surface fire.

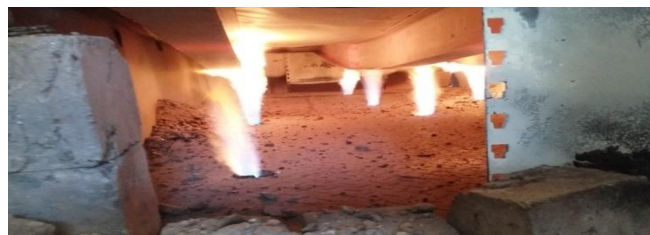
Fig. 4. Burning of specimen stage (Exposing to fire flam).

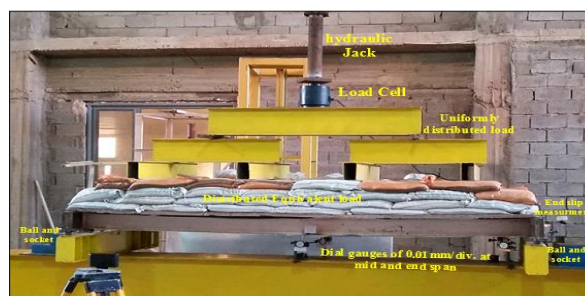
Fig. 6. Test setup through loading stage.

- Load application test: after finishing the first stage of exposure to high temperature with equivalent load test, all specimens including the fourth specimen ($SB-RC_R$) which was left at ambient temperature without burning as a reference, were loaded till failure by distributing the load on all of the specimens' top surfaces as shown in Figs. 5 and 6.

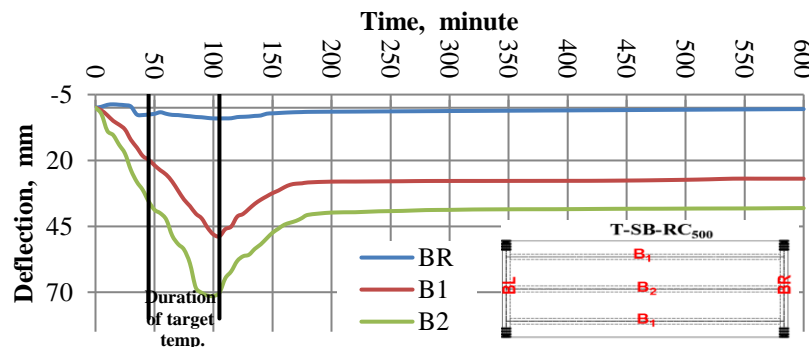
Fig. 9. Mid span deflection-time history of burned beams of composite SB-RC deck floor at temperature 500 °C.

Figure 9 shows the deflection of $SB-RC_{500}$ specimen through the three periods of burning, reaching target temperature of 500 °C, and cooling. Both secondary steel beams showed the same behaviour of a high rate of midspan deflection, but B_2 was more than that of B_1 during the first period which it took approximately 45 minutes of burning before reaching the target temperature. The measured deflection at this time was 35.2 and 19.7 mm, respectively. During the second period of constant burning temperature, the same rate of increase in midspan net deflection was observed. At the end of this period (after 105 minutes), the measured deflection at this moment was 71.4 and 48.8 mm, respectively. The descending of the curves through this period is more than that of burning composite SB-RC deck floor at 300°C. At the beginning of the cooling process, they exhibited a high rate of recovered deflection, but this rate subsided after a short period of time. It can be seen that from time 200 minutes till about 600 minutes, approximately, no deflection is recovered, and the residual deflection was 38.3 and 26.9 mm, which means that the recovered deflection was 46 and 45 %, respectively.

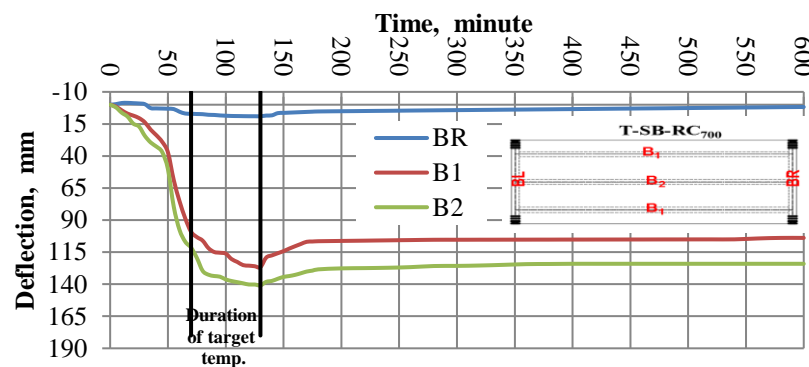
Fig. 10. Mid span deflection-time history of burned beams of composite SB-RC deck floor at temperature 700 °C.

Figure 10 shows the deflection of the burning of a composite SB-RC deck floor at 700 °C. It took 70 minutes to reach the target temperature. The rate of deflection of both secondary steel beams with time was approximately the same through this period, but they were slightly deviated at the end of this period at 111.5 and 99.1 mm, respectively (Table 2). When the specimen burned with a constant temperature of 700 °C through the second period, the rate of descending curves was approximately the same but with a significant deviation between them, B_2 steel beam deformed more than that of B_1 , it reached 140.2 and 126.6 mm, respectively, meaning that 10 % is the difference between them. This deviation continued through the cooling period, and a small amount of the total deflection was recovered, the residual deflection was 124.1 and 103.8 mm, respectively, so the percentage of recovered burning deflection was only 11 and 18 %, respectively. This reflects the amount of damage that takes place in both of the secondary steel beams.

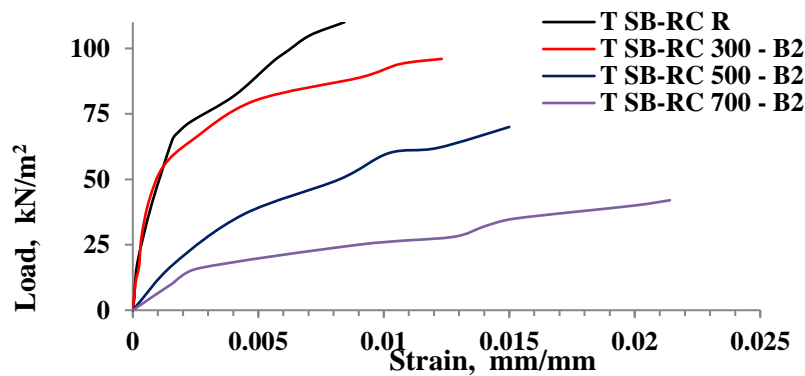
Fig. 15. Load versus bottom steel flange strain of burned specimens of B₂ beam at different temperatures.

Figures 15 and 16 show strain versus applied load of composite SB-RC deck floors burned at different temperatures. It can be seen that the strain increases as the burning temperature increased. The linear portion of the curve which was adopted as a reference for comparison (servisibility limit), decreased as the burning temperature increased. Depending on the service limit of the linear curve portion which had been specified, the increase in generated strain rate compared to the unburned composite SB-RC deck floor was 150, 450 and 842 % for B2 steel beam, and 145, 466 and 933 % for B1 at a burning temperature of 300, 500 and 700 $^\circ\text{C}$, respectively (Table 5). All these observations indicate that the deteriorations increase and the floor system servicibility decreases as the burning temperature increased, especially, when the composite SB-RC deck floor exposed to temperatures reaching up to 500 as well as 700 $^\circ\text{C}$.

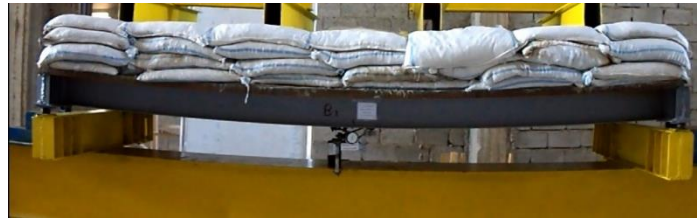
Fig. 17. Failure of control composite SB-RC deck floor (T SB-RC_R).

Figure 17 shows the failure of unburned composite SB-RC deck floor, which has been consisted, excessive deflection and increase in measured strain for both bottom steel flanges and top concrete. When the specimen could not resist the applied load, these loadings were removed, including the equivalent load, permanent deformation, and the formed cracks in the concrete were observed.

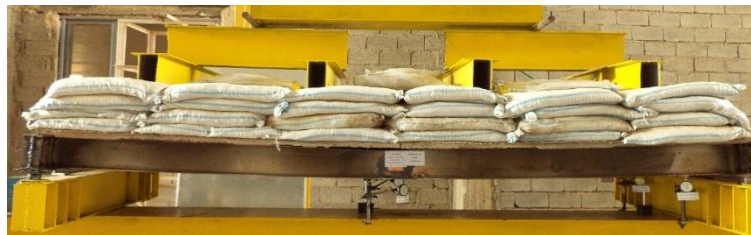
Fig. 18. Failure of burned composite SB-RC deck floor (T SB-RC300) after loading stage.

Figure 18 through 20 show the failure of burned composite SB-RC deck floors, which had approximately the same behaviour, but these specimens were predamaged as a result of the burning stage. Obviously, exposing to fire flame causes damages in concrete as well as steel beams, and these damages increase as the burning temperature is increased. This has affected the ultimate load resistance and the failure of these specimens. These specimens failed by yields of middle secondary steel beam B_2 , followed by the two lateral ones, B_1 . With increasing the applied load, excessive deflection was monitored till no additional load could be applied. Specimens' mid span deflections were proportional to the span length in two directions, due to their structural composition.

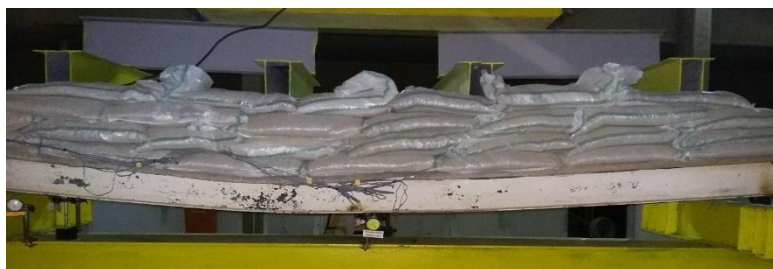
Fig. 19. Failure of burned composite SB-RC deck floor (T SB-RC500) after loading stage.

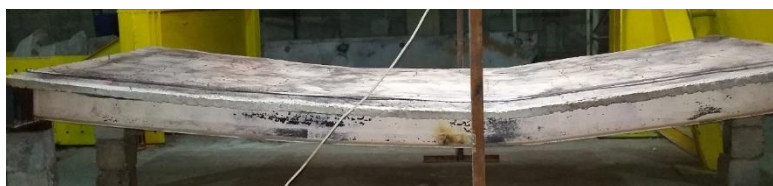
Fig. 20. Failure of burned composite SB-RC deck floor (T SB-RC700) after loading stage.
