## Evaluating Damaged Concrete Depth in Reinforced Concrete Structures under Different Fire Exposure Times by Means of NDT and DT Techniques

ENGINEERING JOURNAL Volume 21 Issue 7

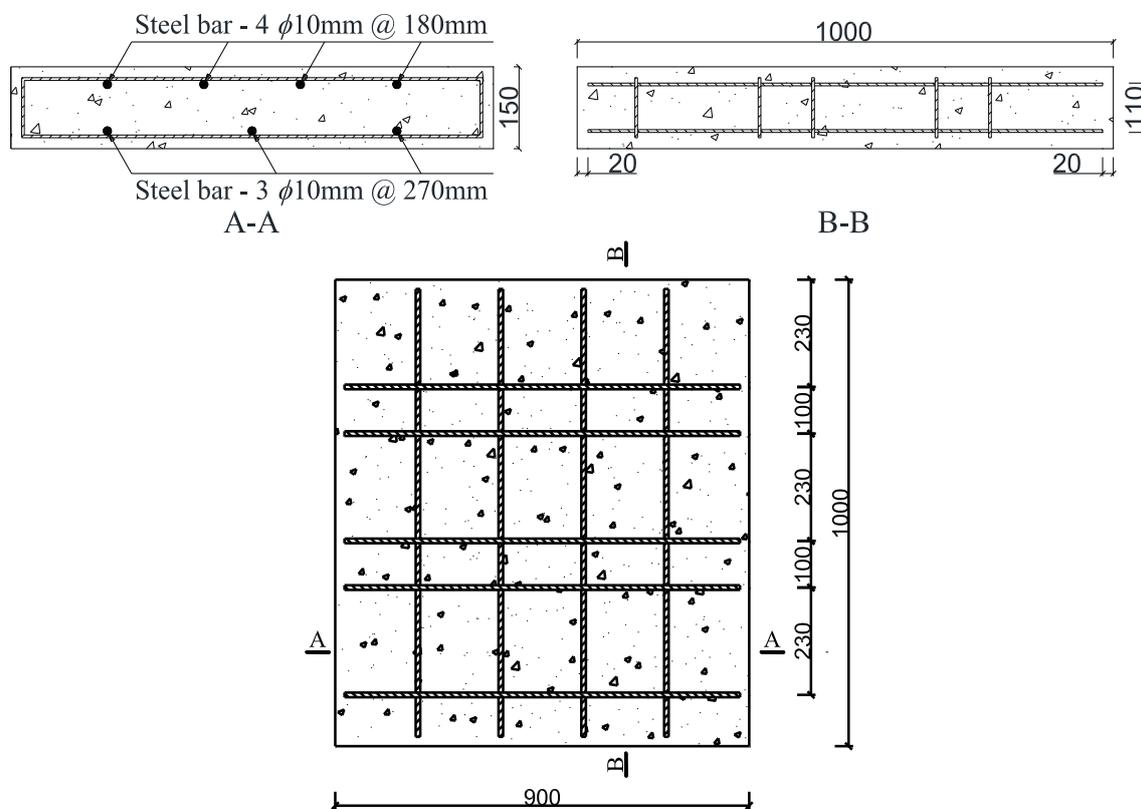
Fig. 1. The design of the RC slabs.

Reinforced concrete slabs were designed under standard ACI 318-08 [14] and cast in the Concrete Laboratory for a total number of 10 specimens. The design of the slabs is shown in Fig. 1. Ready mixed concrete was used with two concrete grades of 24 and 35 MPa. The concrete was made with limestone aggregate as this is the usual aggregate used in Thailand. The slabs had dimensions of 1,000x900x150 mm and were reinforced longitudinally with 10 mm diameter steel bars. Only one side in each slab was exposed to fire. Among the specimens, two were used as control specimens while the others were subjected to fire. The details of all specimens are shown in Table 1.

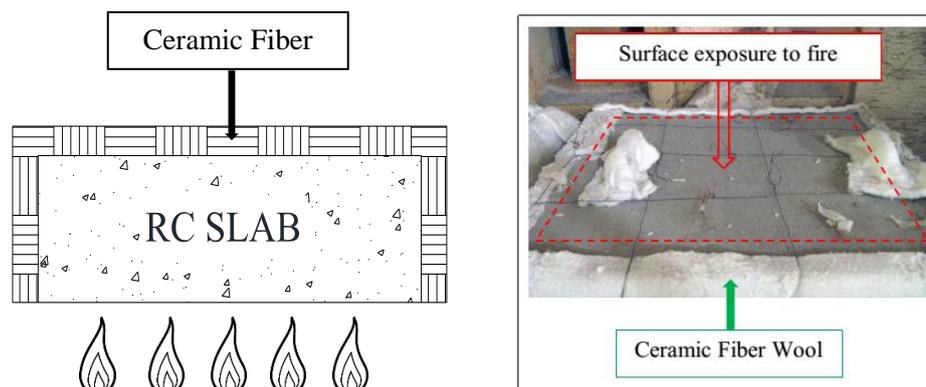
Fig. 2. Slabs were covered in ceramic fiber wool on 5 sides before the test.

The conditions of the fire test were operated under ASTM E119 standard [15]. The specimens were cured for 1 month before testing in a furnace. To evaluate the effect of heating time, the slabs were divided into four groups corresponding to fire exposure times of 30, 60, 90 and 120 minutes. In every specimen, five sides were covered by high temperature insulation consisting of ceramic fiber wool to ensure that only one surface would be exposed to the fire (Fig. 2). Moreover, the thermocouples were also installed at four different depths (0, 25, 75 and 125 mm) from the exposure surface to record the temperature during the test.

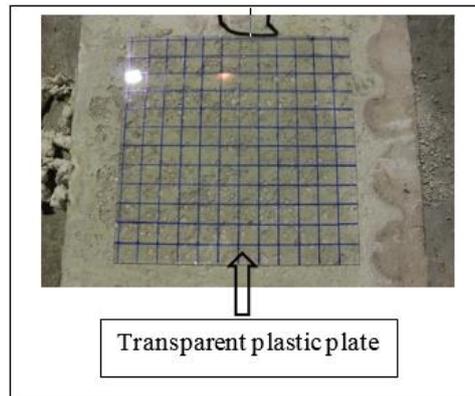
Fig. 3. Transparent plastic plate on exposure surface.

After the fire test, all of the specimens were moved from the furnace and stored at room temperature for three days. The first assessment consisted of a visual observation for every slab to determine the degree of damage to the exposure surfaces. This evaluation was performed by using a transparent plastic plate as shown in Fig. 3. The plastic plate had dimensions of 60x60 cm and was divided into 144 small rectangles with dimensions of 5x5 cm. Using this method, the area of concrete spalling could be drawn on the plastic plate before being calculated. In this research, the degree of damage on exposure surface was quantified based on the criterion:

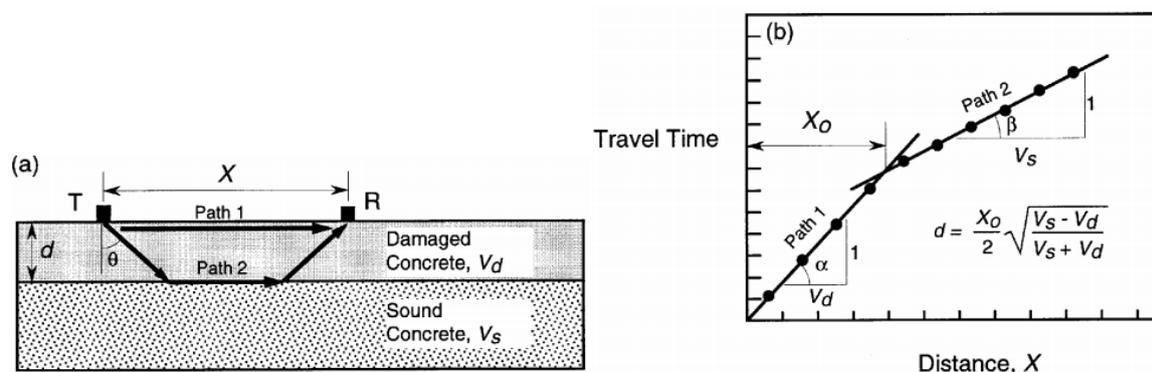
Fig. 4. (a) Wave paths for ultrasonic testing on surface of concrete with a damaged surface layer; and (b) Travel time as a function of distance between transmitter and receiver [16].

Following the visual inspection, UPV testing was performed to measure the depth of the fire-damaged concrete layer. This test was conducted under standard ACI 228.2R-98 [16] based on the following principle: the speed of propagation of stress waves depends on the density and the elastic constants of the solid. The fire-damaged layer has a lower wave speed than the underlying non-damaged concrete. This test can be depicted as shown in Fig. 4. The method assumes that the stress waves' arrival at the receiver occurs along two paths: Path 1, which is directly through the damaged concrete, and Path 2, which is through the damaged and the non-damaged concrete. For small separations, the travel time is shorter for Path 1, while for large separations, the travel time is shorter for Path 2. By plotting the travel time as a function of the distance  $X$ , the presence of the damaged surface layer is indicated by a change in the slope of the data. The depth of the damaged layer is found from the following:

where  $X_0$  is the distance in which the travel times for the two paths are equal and is found from the intersection of the straight lines in Fig. 4 (b).  $V_S$  and  $V_D$  are the wave speeds in the damaged and the non-damaged concrete.

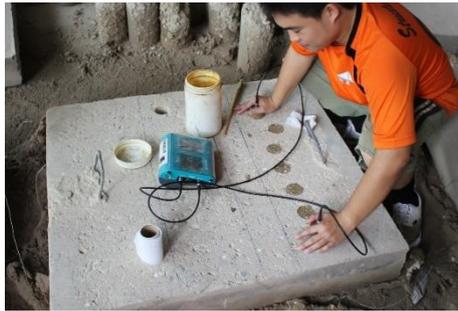
Fig. 5. UPV test on fire-damaged slabs.

In this experiment, the UPV test was performed with a frequency of 54 kHz and the measured positions were marked by lines with intervals of 100 mm. Data were collected both forwards and backwards in each line (Fig. 5).

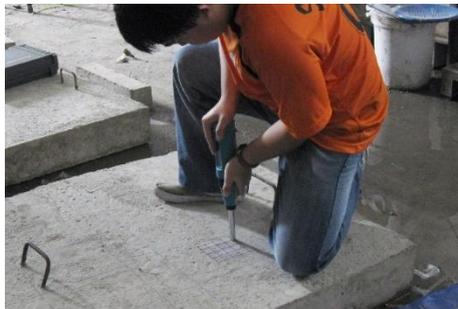
Fig. 6. Schmidt rebound hammer test.

Another NDT method, the Schmidt Rebound Hammer, was performed on the fire-damaged surface to determine the surface hardness of the concrete in each slab. The test was carried out on six locations of each slab and 16 testing points were recorded on each location (Fig. 6). This test was conducted based on standard ASTM C805 / C805M-13a [15].

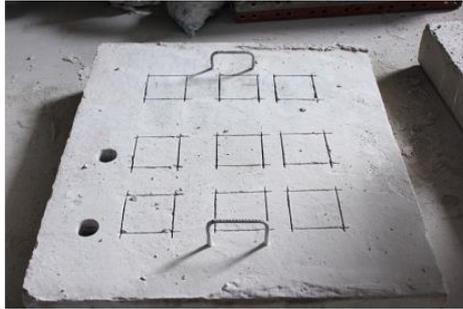
Fig. 7. The positions were located for the pull-off test.

This test was performed based on standard ASTM C1583-04 [19] to evaluate the tensile strength at three depth levels of 10, 20 and 30 mm on the exposure side. In each slab, nine positions were located and divided into three groups that corresponded with three depth levels (Fig. 7). Then, the concrete in each group was carefully removed using a drilling machine operated until the maximum level of its cutting depth, as shown in Fig. 8. All of the new surfaces after cutting were grinded to prepare for the pull-off test (Fig. 9). A 50 mm diameter circular steel disk was attached to the new surface by epoxy adhesive (Fig. 10). The force required to pull the disc from the concrete surface by hand-operated loading equipment was measured and calculated to obtain the tensile strength.

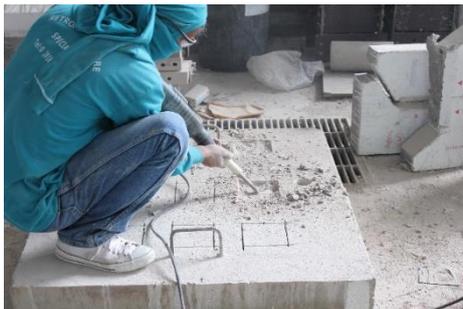
Fig. 8. Removing concrete via drilling machine.

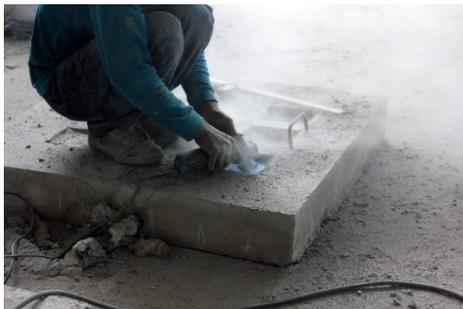
Fig. 9. Smoothing the surface of concrete.

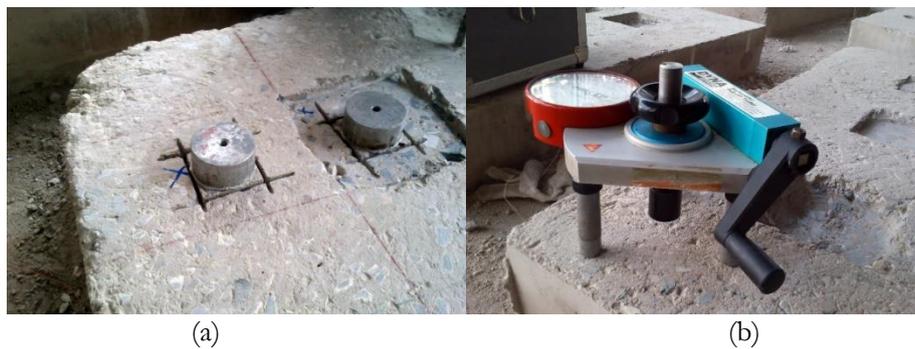
Fig. 10. Installing pull-off test: (a) the steel disk; (b) the tensile loading device.

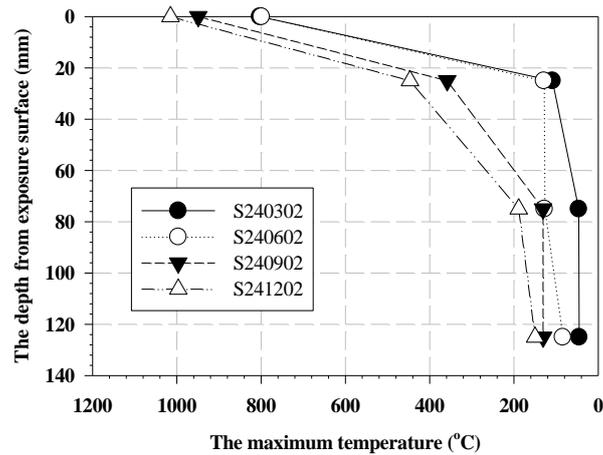
Fig. 11. The maximum temperature recorded at different depth levels for the 24 MPa slab.

The maximum temperature at the exposure surface and three other depth levels (25, 75, 125 mm) in each specimen are reported in Table 2. Moreover, the change of the highest temperature on the depth of concrete is represented in Fig. 11 and Fig. 12. Due to the breaking of thermocouples in the depths of 75 and 125 mm, the values of maximum temperature at these positions were not recorded in the case of slab S351202. However, it could be observed in all specimens that temperature generally reduced corresponding to increased depth from the exposure surface as concrete is a poor conductor of heat [5], due to its incombustible nature and its low thermal diffusivity, which guarantee a slow propagation of thermal transients within the structural members [20].

In all cases, the increase of fire exposure time led to the increase of temperature at every evaluating location. However, the increase became significant as the time surpassed 60 minutes. At the depth of 25 mm, the temperature increased 30°C as the fire exposure time reached 60 minutes compared with the heat increase at 30 minutes. Meanwhile, the heat increased more than 250°C as the time rose over 90 minutes in comparison with the heating time of 30 minutes. This change was observed in both series of 24 and 35 MPa concrete.

Regarding to the alteration of temperature on further depth, the heat dropped through concrete over 25 mm with a reduction of approximately 600°C. Nevertheless, the decrease became smaller at deeper levels.

Moreover, referring to the temperature profile in Fig. 11 and Fig. 12, the specimens that were heated for 90 and 120 minutes showed a temperature of over 300°C at a depth of 0 – 60 mm from exposure surface. When heating concrete above 300°C, the color of concrete can change [6]. Therefore, the observation of the depth of color change in coring test was appropriate with the temperature obtained.

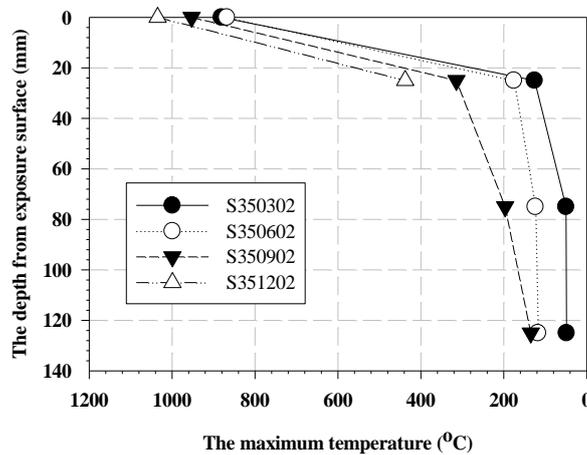
Fig. 12. The maximum temperature recorded at different depth levels for the 35 MPa slab.

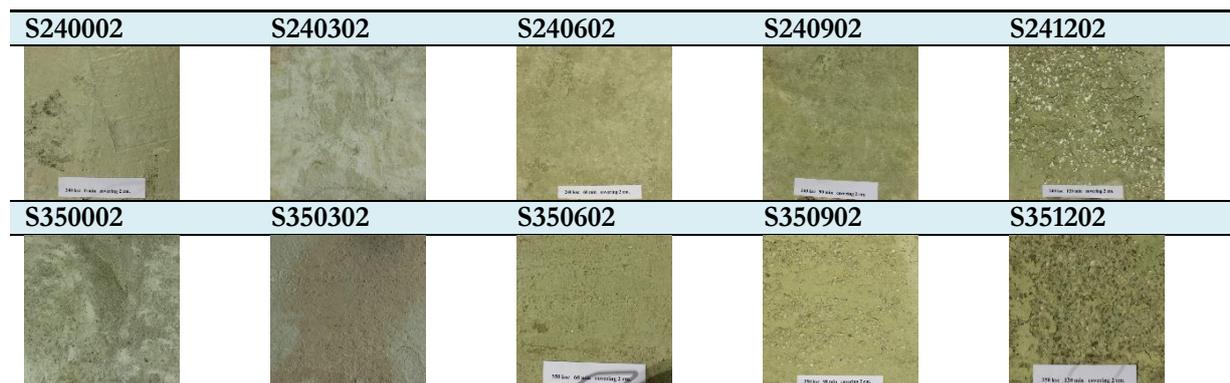
Table 3. The observation on fire exposed surface of specimens.

The assessment began with visual observation of color change, cracking and spalling of the concrete surface. It was observed that cracks appeared on exposure surface in all slabs and the spalling area was larger on specimens that had longer fire exposure times (Table 3). Based on the data from the thermocouples on the exposed surfaces, all of the specimens were heated to over 800°C. At this temperature, the cracks became very pronounced and increased extensively at 1000°C [9]. After exposure to the fire, the exposure surfaces showed a brighter color due to the limestone. At temperatures above 700°C, carbonate aggregate decomposes into CaO and CO<sub>2</sub> resulting in brighter colors due to the lime's whitish tint [21].

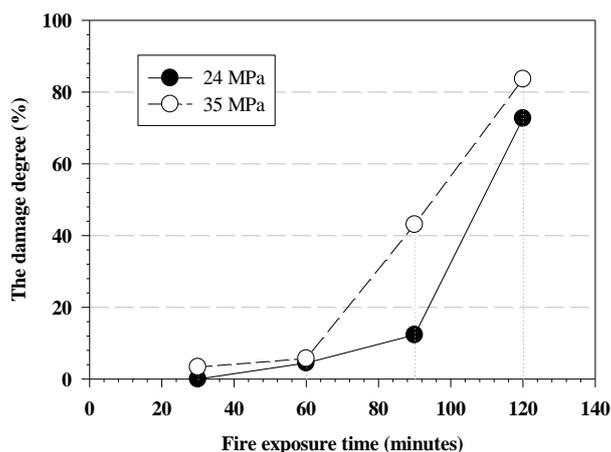
Fig. 13. The effect of fire exposure time to the damage degree.

The second visual inspection determines the degree of damage on the exposure surfaces using a transparent plastic plate as mentioned above. The area of spalling was reported (Table 4) and compared with the control specimens in order to estimate the change caused by high temperatures. Next, an evaluation on the effect of fire exposure time to the degree of damage were drawn in Fig. 13. The graph shows that the increase in fire exposure time led to a raise in the degree of damage on the concrete surface. The area of spalling was not much different in the slabs exposed to fire for 30 and 60 minutes. Obtained values were less than 6%, while the results from the other specimens were more than six times higher. A remarkable increase was recorded for the slabs exposed to fire for more than 90 minutes. This could be explained by the high

The longer exposure time, the more spalling was observed on concrete surface, especially for samples with more than 90 minutes of exposure time. Meanwhile, the slabs with a heating time of 30 minutes exhibited the lowest values of damage. Another observation showed that the 35 MPa slabs exhibited a higher degree of damage than the 24 MPa slabs in all cases of exposure time. It is possible that the higher concrete grade specimens could be denser and therefore this might stop the water vapor inside the concrete from escaping from the concrete mass, which increases the susceptibility of spalling under fire conditions [22].

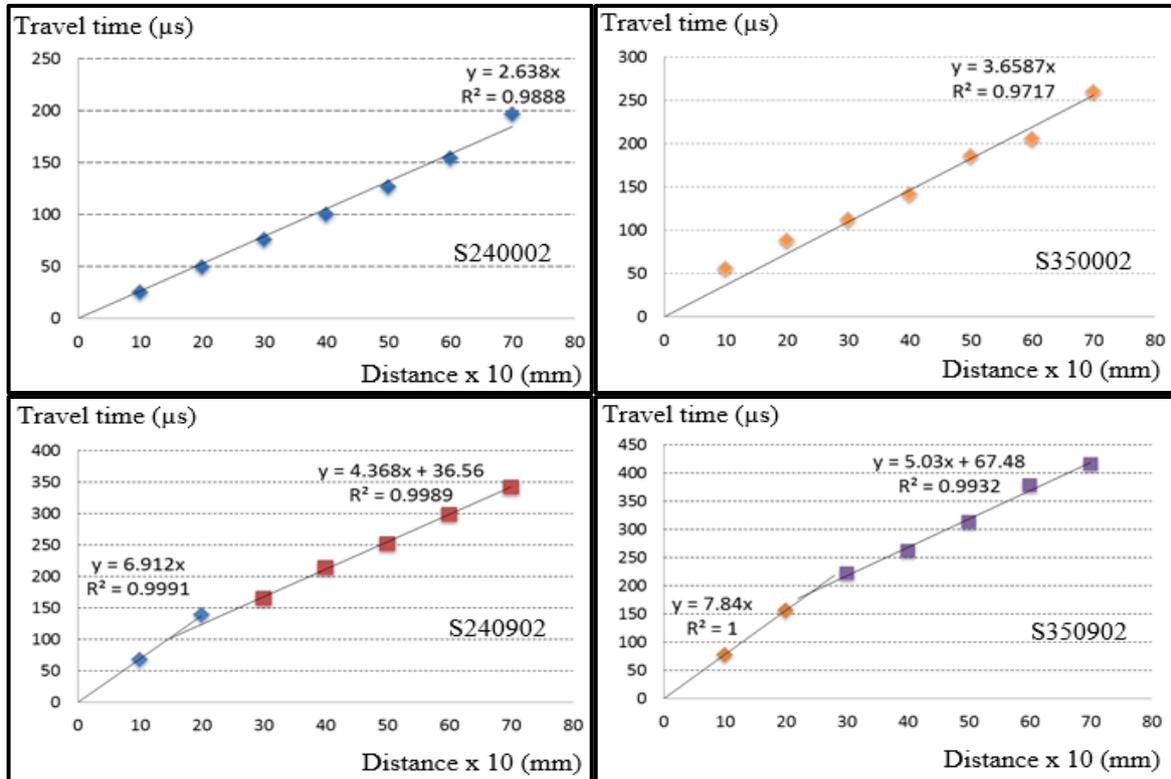
Fig. 14. Results of the UPV test.

The results from the UPV test showed that the intersection of the straight lines, corresponding with two paths as mentioned above, can be observed for specimens S240902 and S350902 as shown in Fig. 14. Therefore, the depths of fire-damaged layers calculated using Eq. (2) were 34.1 mm (S230902) and 56.1 mm

(S350902). In contrast, only a straight line was observed in the graphs of control specimens (S240002 and S350002) since there were not damaged concrete layers in these cases (Fig. 14). In the other slabs, the intersection between the straight lines matching with two wave paths was not clearly observed. Consequently, values of the damaged concrete depth were not calculated for the slabs exposed to fire for 30, 60 and 120 minutes.

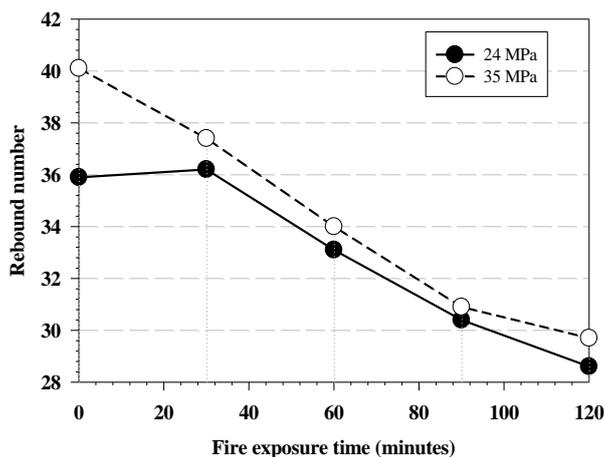
Fig. 15. The correlation between rebound number and fire exposure time.

After testing by UPV, another situ technique (the Schmidt Rebound Hammer test) was used to determine the surface hardness of the concrete after fire exposure based on the rebound number recorded. The results of this test are reported in Table 5 and Fig. 15 in terms of the correlation between the rebound number and fire exposure time. In case of control specimens for the 24 and 35 MPa slabs, the values of the rebound number were 35.9 and 40.1. Based on the chart in Fig. 15, the rebound number in two series of slabs decreased when the heating time was longer than 30 minutes. The lowest values obtained for the rebound number were below 30 in the slabs with a fire exposure time of 120 minutes.

As a result, longer fire exposure times resulted in lower rebound numbers, indicating more decrease in the concrete strength. These results were compatible with visual observation as the specimens with a long heating time showed higher degrees of damage on the concrete surface. Moreover, Fig. 16 shows the remaining rebound number (in percentage) of heated slabs compared to the results of control specimens. The results from the 35 MPa slabs were lower than the values obtained from the 24 MPa slabs. This indicates that the hardness of the surface on the 35 MPa slabs is lower than the 24 MPa slabs after fire exposure, which is similar to the results of the degree of damaged observed on the surface of the slabs as mentioned above.

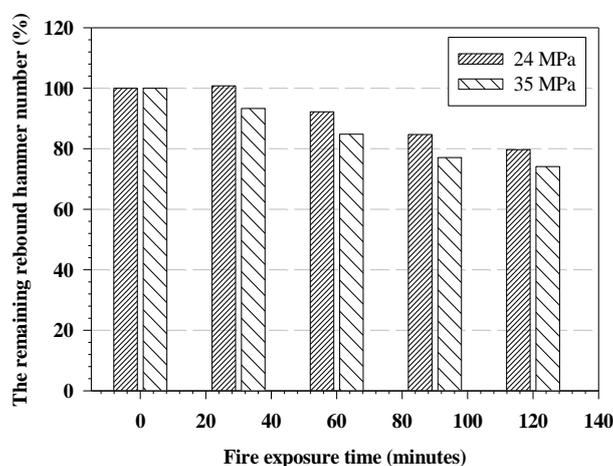
Fig. 16. The remaining rebound hammer number (%).

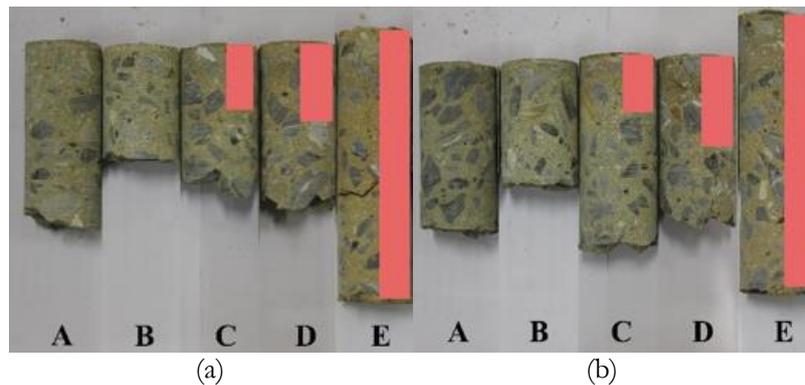
Fig. 17. Observation of the depths of color change in slabs 24 MPa (a) and 35 MPa (b).

In this test, concrete cores (diameter of 50 mm) were drilled in each slab in order to measure the depth of color change inside the specimens (Fig. 17). The values are reported in Table 6. Based on the observation of color change in the concrete cores, the depth of color change increased as the fire time increased. With respect to the slabs fired in 30 minutes, the values were very small. Thus, it could be determined that a fire exposure time of 30 minutes did not result in much change inside the concrete.

Meanwhile, the color change was observed in whole positions on concrete cores from the slabs heated in 120 minutes. Consequently, longer fire time such as more than 90 minutes could make change of components in all concrete parts of the slab even for the location far from exposure surface.

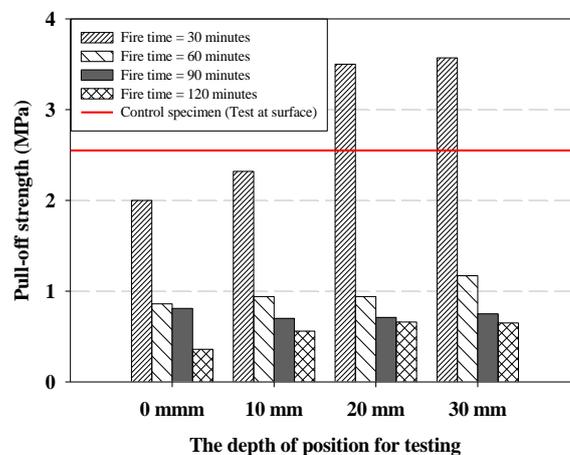
Fig. 18. The effect of fire exposure time to the pull-off strength in specimens of 24 MPa.

From those figures, it can be seen that the pull-off strengths achieved in specimens with fire exposure time of 30 minutes were significantly higher than the other specimens. This occurred at all of depth levels in both concrete grades. Therefore, the long exposure time (of more than 30 minutes) causes a serious decrease in tensile strength of concrete with the lowest strength value obtained after the longest heating time (120

minutes). In general, at each depth level, the pull-off strengths decreased corresponding with the increase in fire exposure time.

In addition, an increase in the pull-off strength at further depth levels was observed for each case of fire time. This is due to the decreased detrimental effect of fire at positions farther from the exposure surface as the temperature decreased at deeper concrete layers, as recorded by the thermocouple. Considering the 24 MPa specimens with a heating time of 30 minutes, the pull-off strength at the surface and a depth of 10 mm were lower than the results obtained from the control specimen. However, higher values were recorded at the depths of 20 and 30 mm. On the other hand, the pull-off strengths at all evaluated depths of 35 MPa slabs were lower than the value of control specimens.

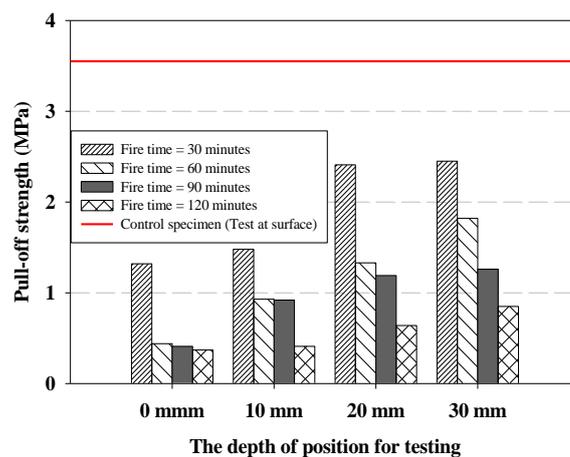
Fig. 19. The effect of fire exposure time to the pull-off strength in specimens of 35 MPa.
