## Basic Study on Detection of Deteriorated RC Structures Using Infrared Thermography Camera

Fumio Yamazaki<sup>1,a,\*</sup>, Hideomi Ueda<sup>2</sup>, and Wen Liu<sup>1,b</sup>

<sup>1</sup> Department of Urban Environment Systems, Chiba University, Chiba 263-8522, Japan

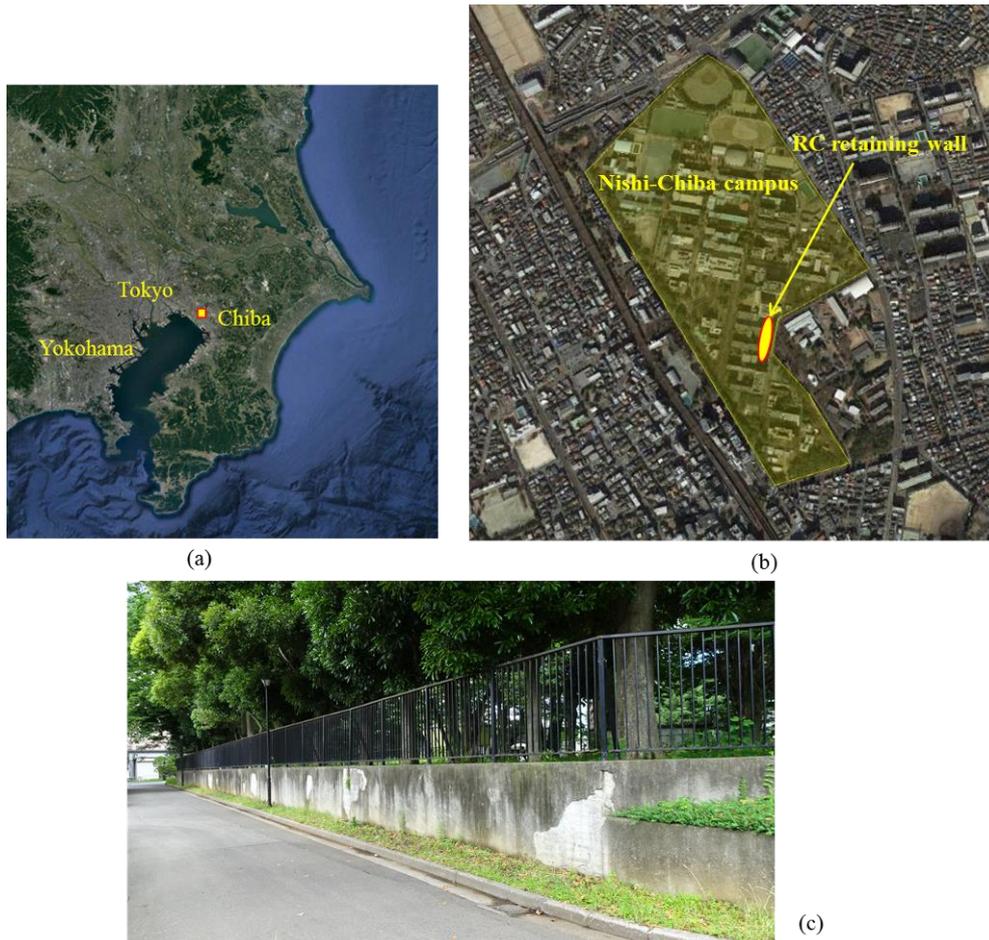
Infrared thermography tests for deteriorated structures were conducted in the Nishi-Chiba campus of Chiba University, Chiba Prefecture, Japan (Fig. 1). There were several concrete surfaces which might be suffered from deterioration. Among them, an existing reinforced-concrete (RC) retaining wall shown in Fig. 1(c) was selected as a target object since this wall was seen apparently to be deteriorated, and located at an easy-to-access place. This retaining wall was built in 1962 as a part of boundary fence, which separates Chiba University's campus and the experiment station of the University of Tokyo. The wall is faced to the west and the sun light illuminates it in the afternoon, which provides uniform heating to the wall.

Fig. 1. (a) Location of Chiba City, Japan on Google Earth, (b) Nishi-Chiba campus of Chiba University, and (c) RC retaining wall used in this study.

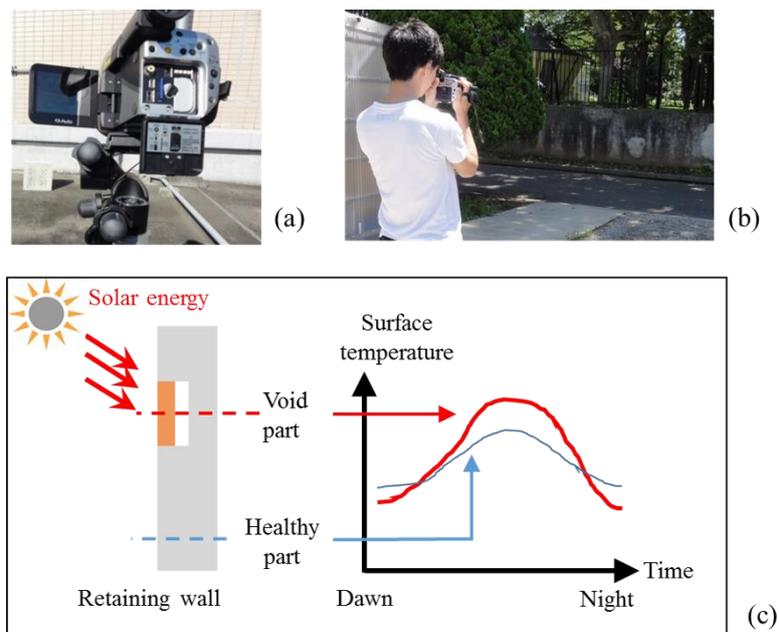
The observation of the RC retaining wall was carried out using an infrared thermography camera InfReC R300SR-S (Nippon Avionics co, ltd. [20]) as shown in Fig. 2(a, b). The camera has the frame rate of 60 Hz, measuring range from  $-40^{\circ}\text{C}$  to  $120^{\circ}\text{C}$ , and sensitivity  $0.025^{\circ}\text{C}$ . The mechanism to detect deterioration of concrete by infrared thermography is shown in Fig. 2(c). If there is a void part near the surface of concrete, its surface temperature increases more rapidly than a healthy part does under the solar illumination because heat transfer by conduction is hindered by the void. Due to the trapped heat, the surface temperature above the void will increase under a heating condition.

Fig. 2. (a) Infrared thermography camera InfReC R300SR-S, (b) a scene of observation, (c) schematic image of surface temperature change of concrete wall.

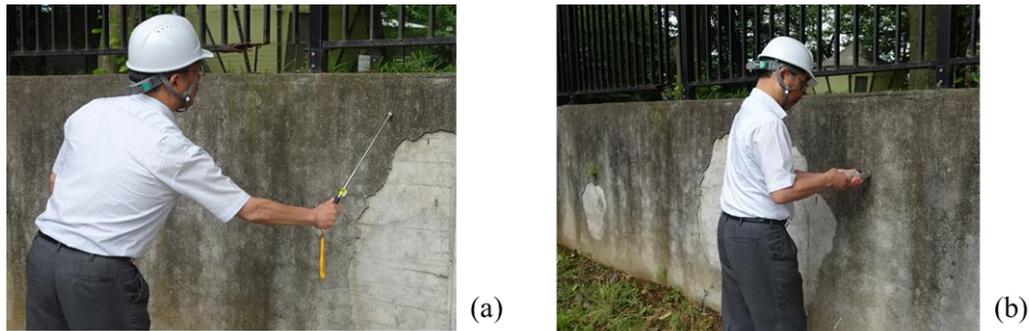
Fig. 3. (a) Scenes of rotary hammering sound test and (b) Schmidt rebound hammer test.

In the thermography diagnosis, the surface temperature was observed by the thermography camera, which evaluates deterioration parts from the temporal change and spatial distribution of temperature. A rotary hammering sound tester [21, 22], shown in Fig. 3(a), was also used for the deteriorated parts that were detected by infrared thermography and their neighboring areas. When the rotary hammer knocked the concrete retaining wall, the sound was recorded by a digital voice recorder and the data were analyzed to characterize deteriorated parts. Additionally, the compressive strength of concrete was also measured by a Schmidt rebound hammer type-N [23, 24] shown in Fig. 3(b). The concrete compressive strength,  $F_c$  ( $\text{N}/\text{mm}^2$ ), can be estimated by the following formula [24]:
